APOLLO 17 MISSION  
ANOMALY REPORT NO. 1

ERRONEOUS MEASUREMENTS TRANSMITTED BY TELEMETRY

APOLLO 17 MISSION  
Anomaly Report No. 1

PREPARED BY  
Mission Evaluation Team

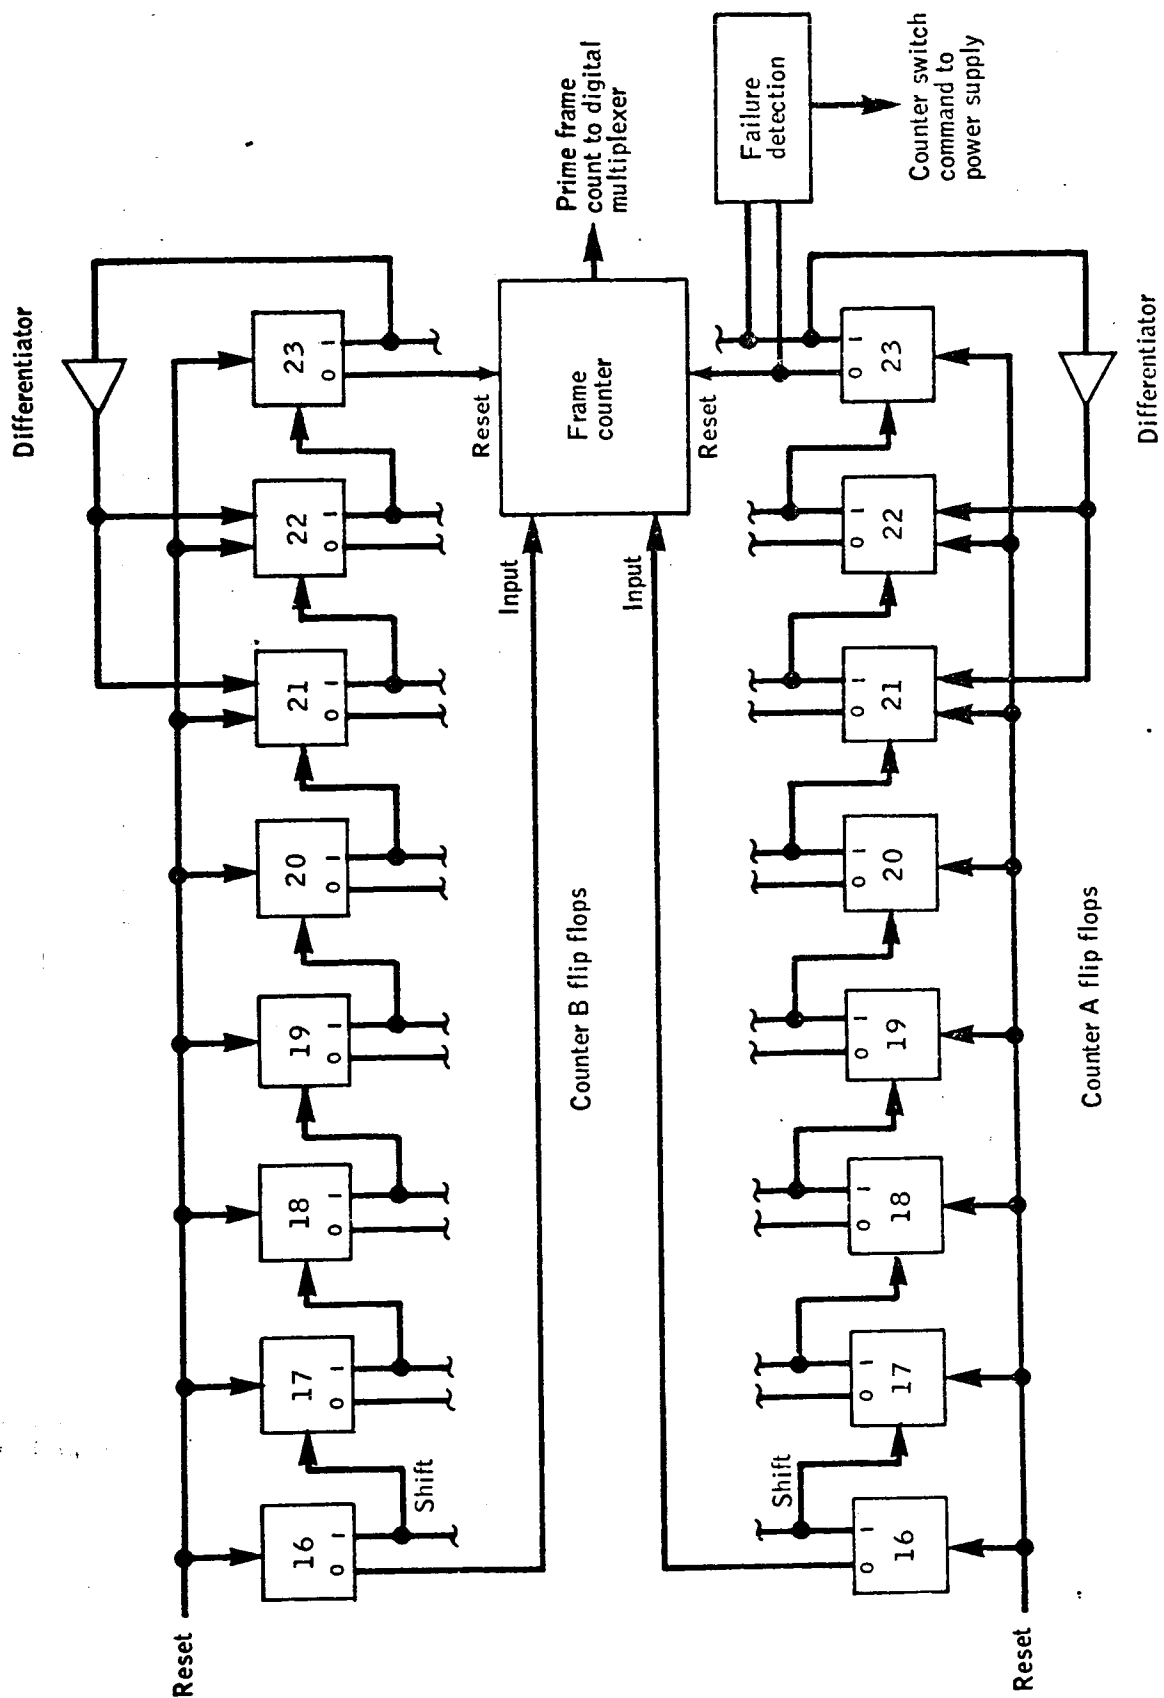
Figure 3.- Prime frame counter control.

The programmer power supply applies power to programmer-counter A when system power is applied. Operation of the last stage of counter A is monitored by failure detection circuitry (fig. 3) so that if the last stage of counter A switches in less time than 0.8 second (0.8 duty cycle) or does not switch during a duty cycle, power is removed from counter A and applied to counter B.

The failure detection circuit must have commanded switchover to redundant counter B at the end of the 114th second of data. The switchover occurred during the 40-millisecond gap and the frame counter was reset to zero by removing power from counter A. At this time, the flip flops in counter B properly came on in states corresponding to frame 1. The ground station then locked up one frame later. The measurement sequencing then skipped from frame 2 (data) to frame 4 (data). The only way this could occur is for counter flip-flop 17 to receive an extra pulse. The spurious pulse could have resulted from the power-up transients that commonly occur at counter switchover.

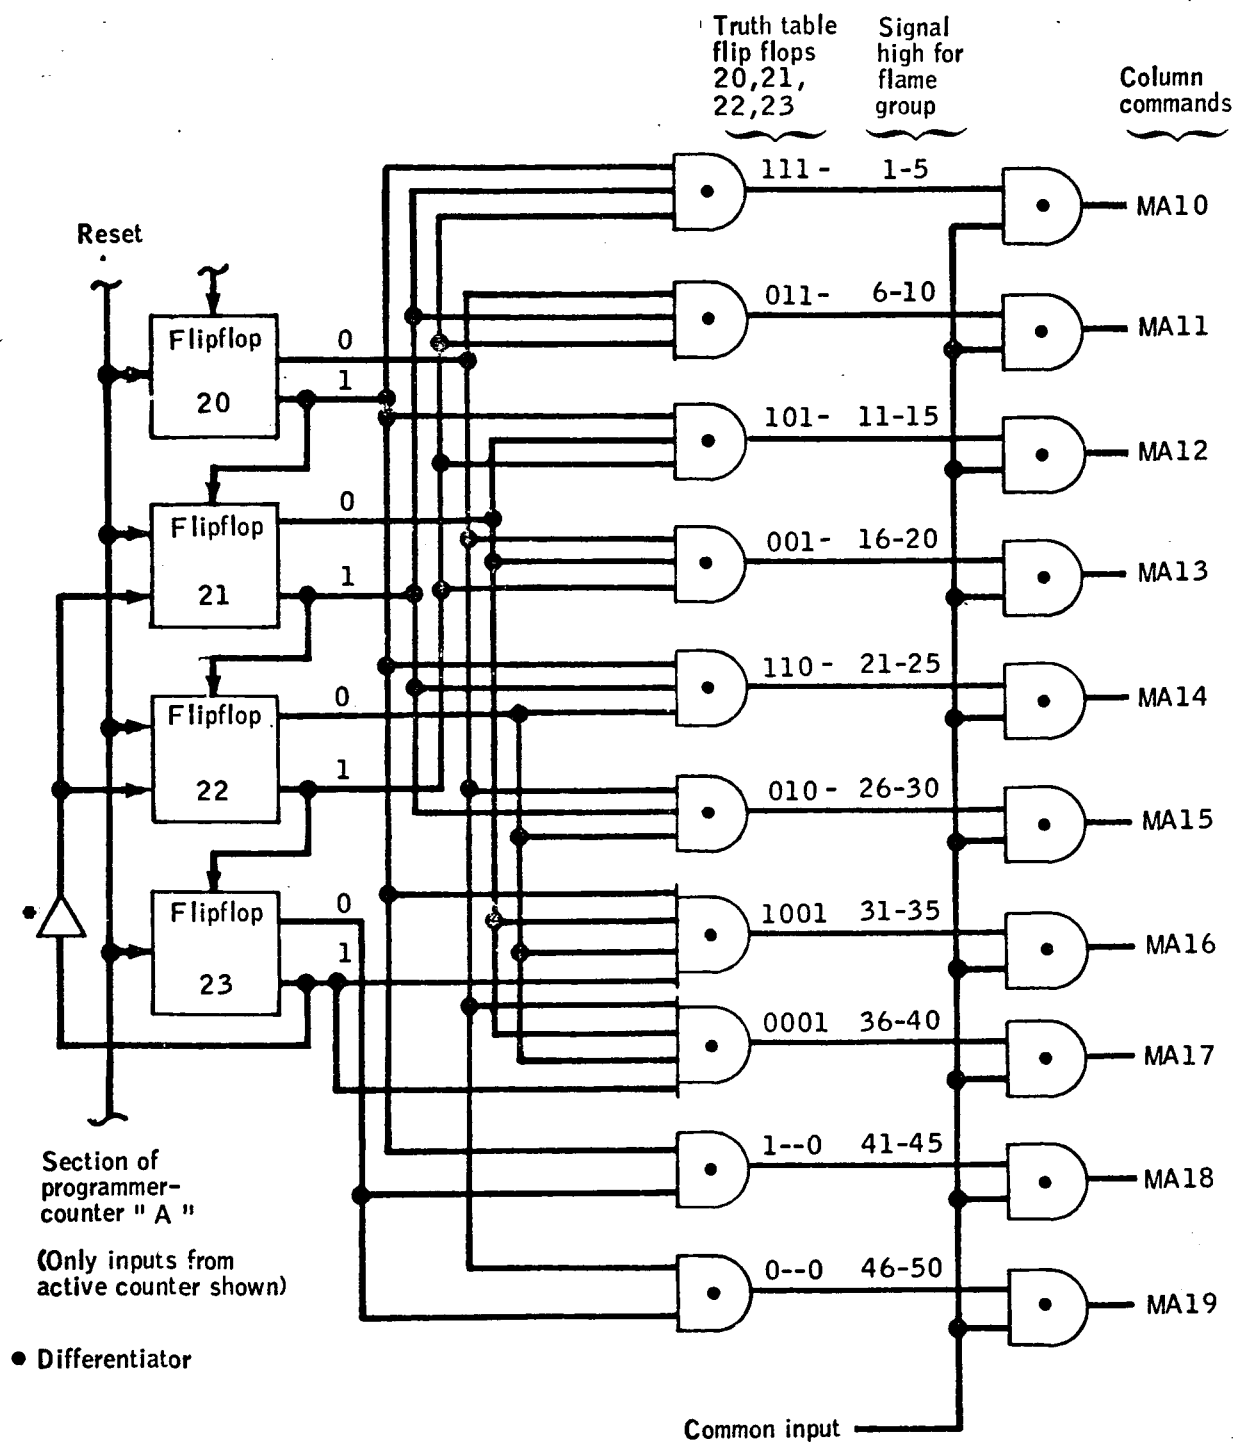
Figure 5.- One sample-per second column command generation.

The 10 column commands, MA 10 through 19 (fig. 5), are derived from 10 pairs of signal inputs. A common signal derived from counter flip-flops 10 through 19 is the first input of all ten pairs. Ten unique 5-frame group signals derived from counter flip-flops 20 through 23 are the second inputs to the 10 pairs. Commands using outputs derived from flip-flops 10 through 19 are also used to control other parts of the system which operated properly. Since flip-flops 20 through 23 are only used to generate column commands MA 10 through 19, the problem must have been confined to flip-flops 20 through 23, or their associated output circuits.

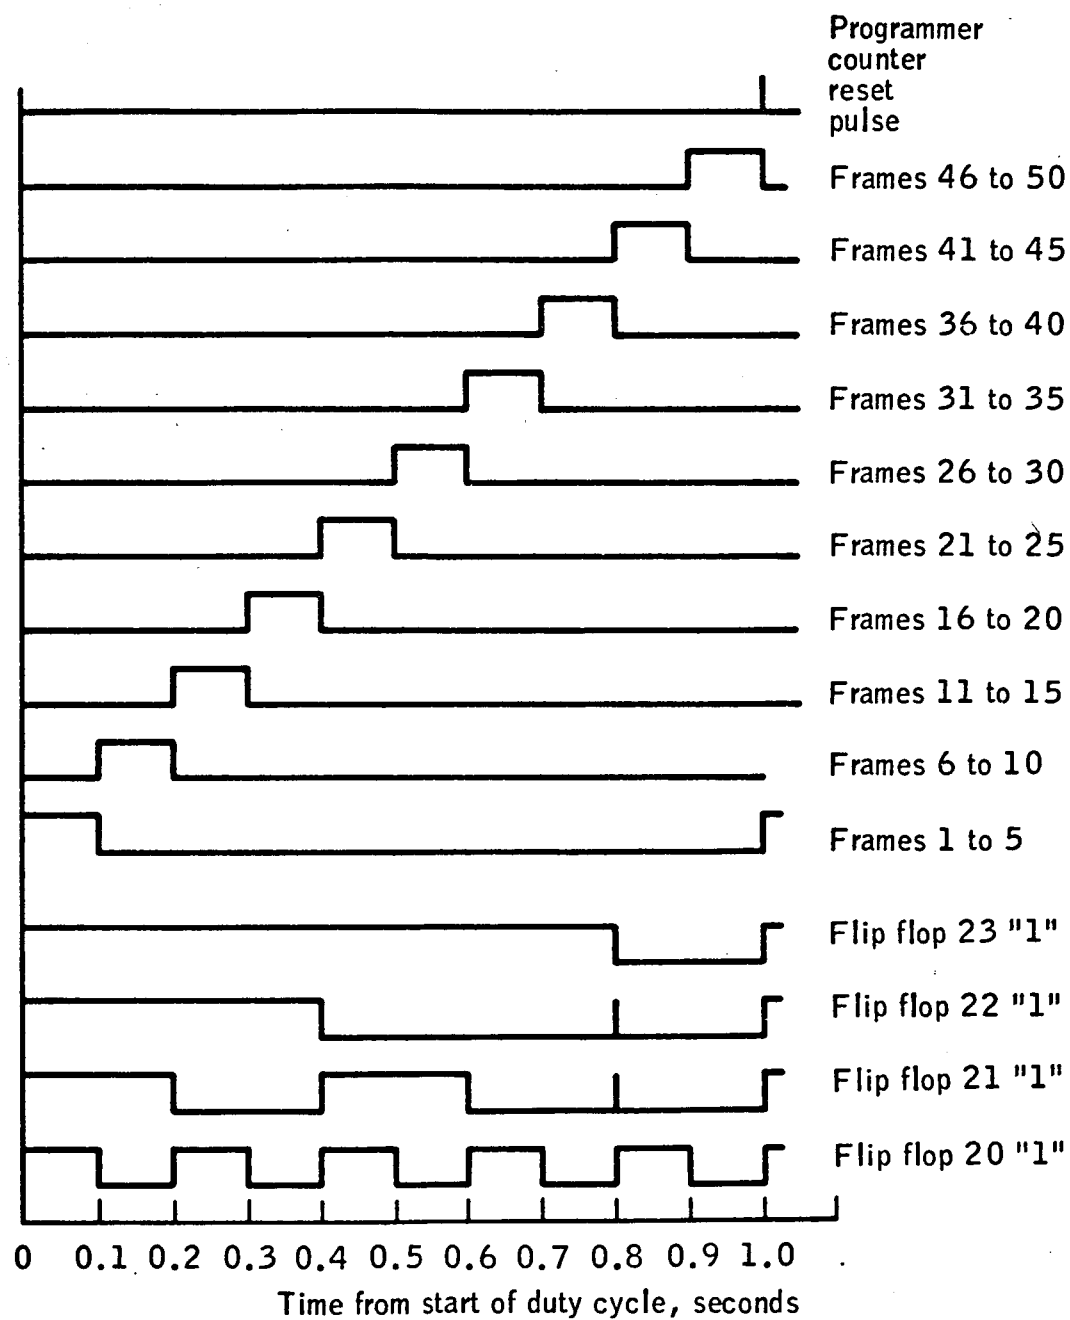
Figure 6. - Timing diagram for normal operation.

Figure 6 is a timing diagram for flip-flops 20 through 23 and the 5 frame group signals. At 0.8 second into the duty cycle, when flip-flop 23 transfers, the differentiator feed-back resets flip-flops 21 and 22 as shown in the timing diagram (fig. 6).

The prime frame counter was reset after prime frame 41 (rather than after prime frame 50, indicating a reset at about 0.82 second) during the second subsidiary glitch. Since the prime-frame counter is reset by flip-flop 23, and the frame counter was reset after prime frame 41, flip-flop 23 must have switched at 0.82 second. Since flip-flops 20 through 23 should not be switching at 0.82 second (fig. 6b), the problem must have been in the last four stages of programmer counter A.
